Fatigue Behavior and Failure Mechanisms
of Centrally Notched [0]₂ and [(0/90)₂]₅
Silicon Carbide Reinforced
Aluminosilicate Glass

THESIS

William R. Moschelle
Captain, USAF
AFIT/GAE/ENY/91D-19

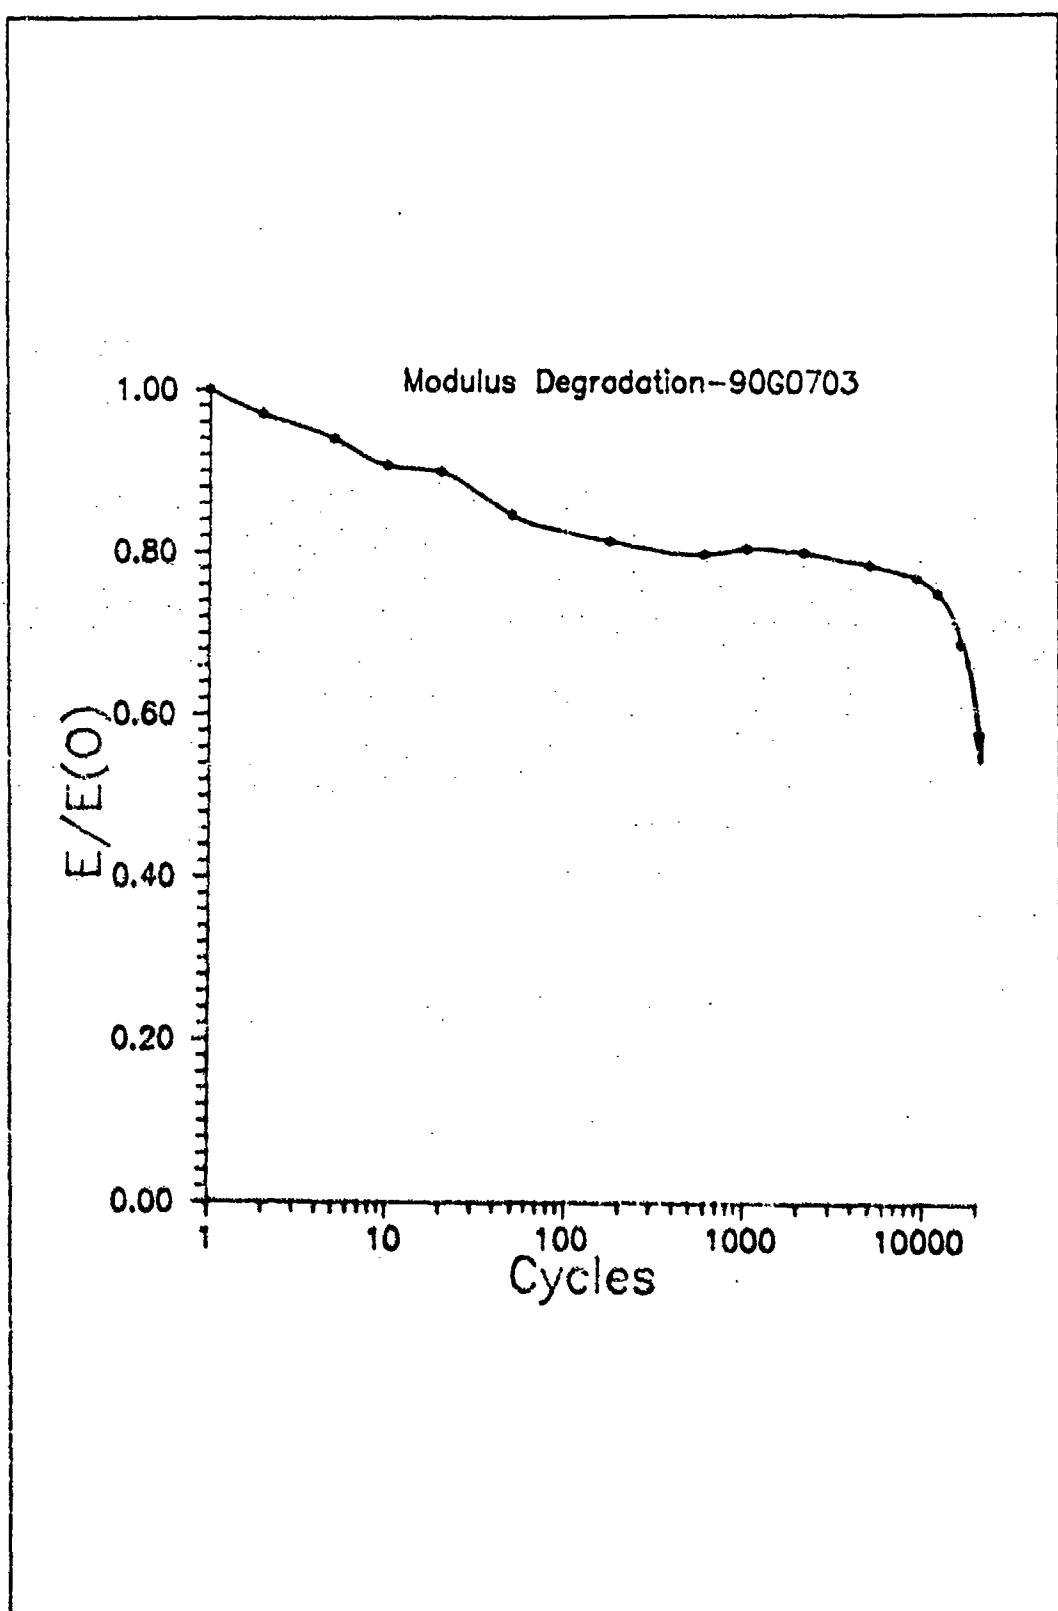
Figure 37 Modulus Reduction 208 MPa Test

The longitudinal modulus degradation is shown in figure 37. There is stable decrease in modulus until ten thousand cycles at which point crack growth begins to grow substantially resulting in a large decrease in modulus. This specimen failed at 17001 cycles.

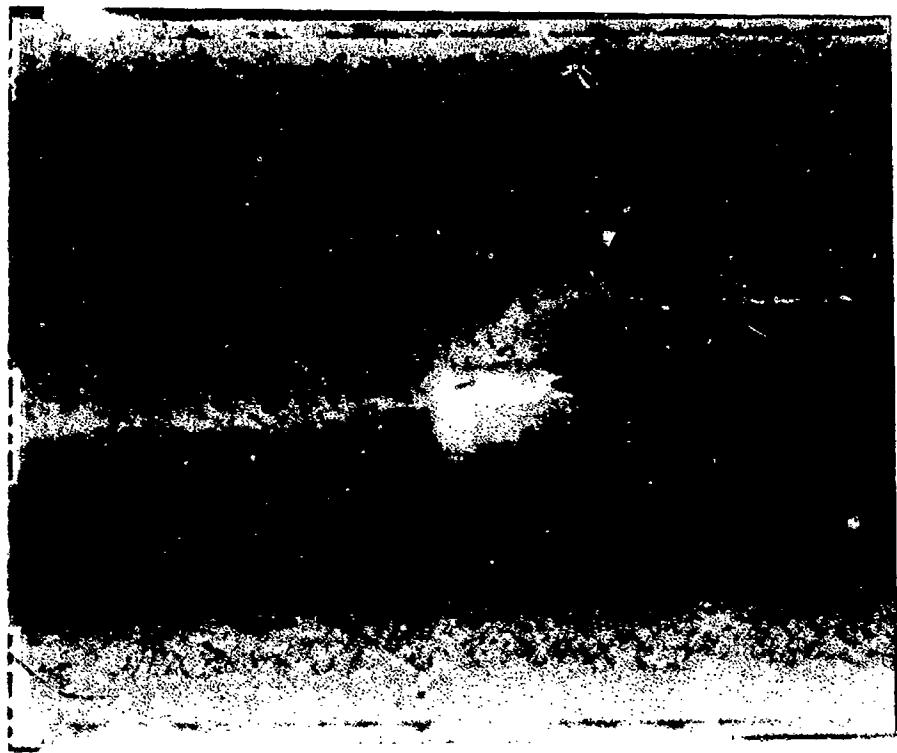
Figure 39 Final Fracture Specimen 90G0703

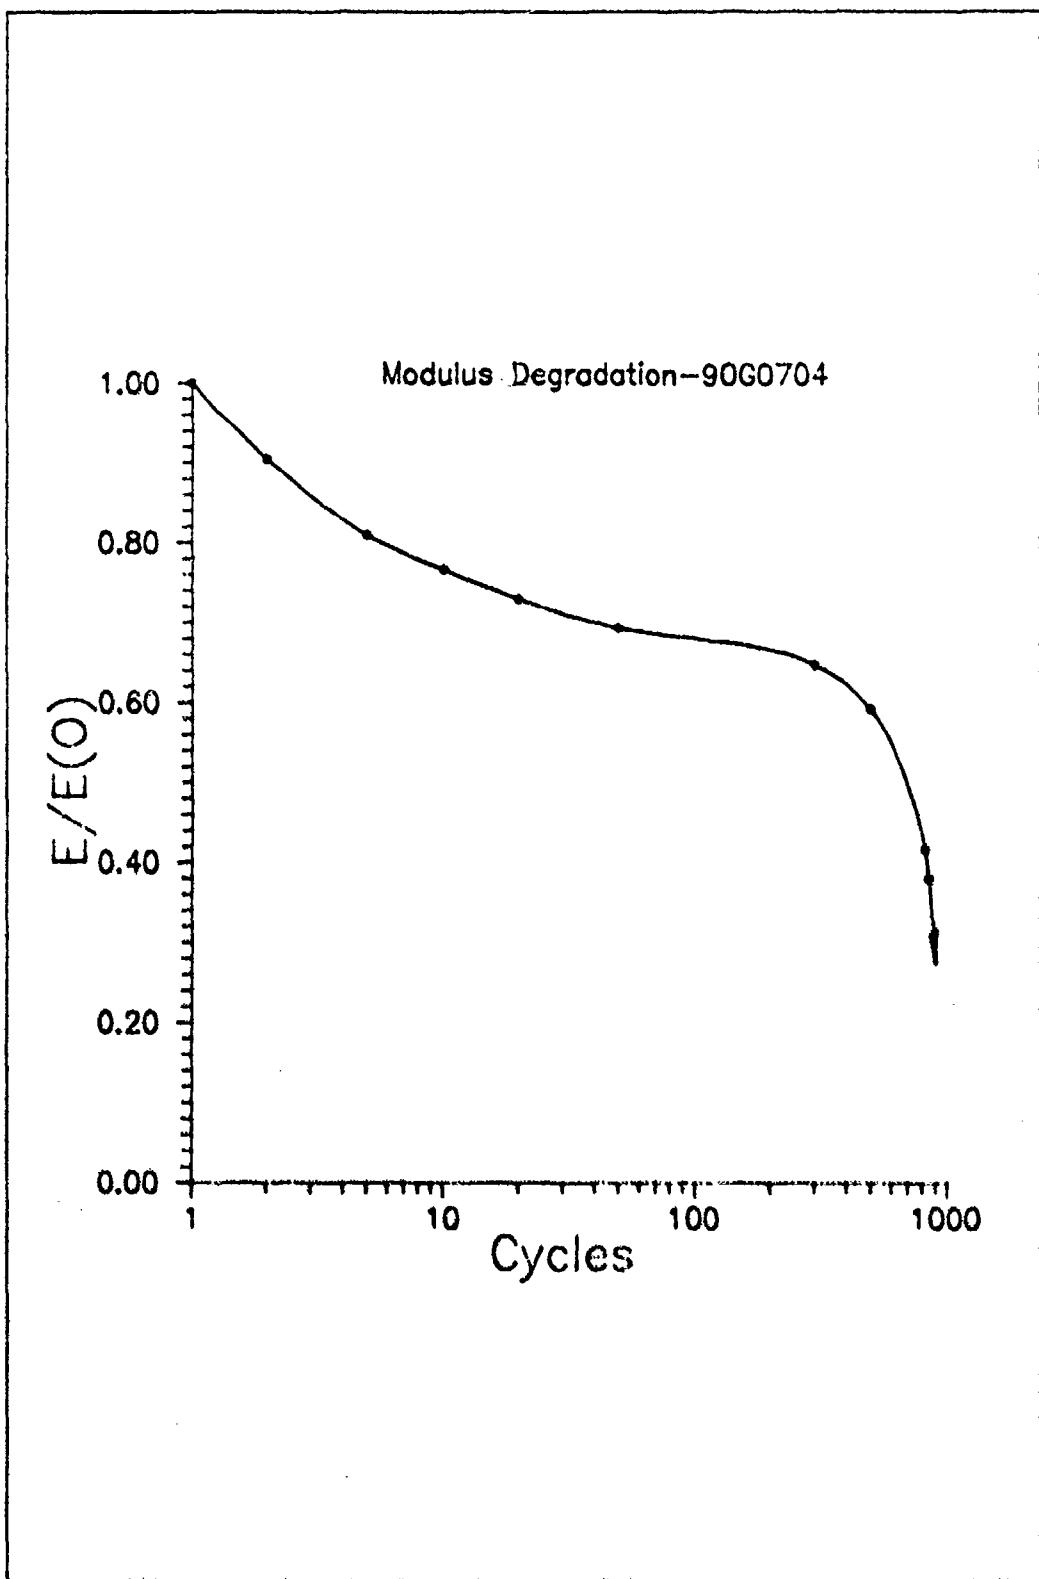
Figure 40 Modulus Reduction 310 MPa Test

The second specimen chosen to fill in the failure points on the S-N curve was 90G0704. This specimen was tested at 310 MPa, eighty-nine percent of ultimate. The specimen failed after 1105 cycles of testing. Modulus degradation is shown in figure 40. This specimen showed a steeper decrease earlier than 90G0703 which is to be expected since the stress is higher and more damage is occurring. Unstable degradation begins at 600 cycles, culminating in failure at 1105 cycles. The fractured specimen is shown in figure 41. The pattern is consistent with all other fractures discussed thus far.

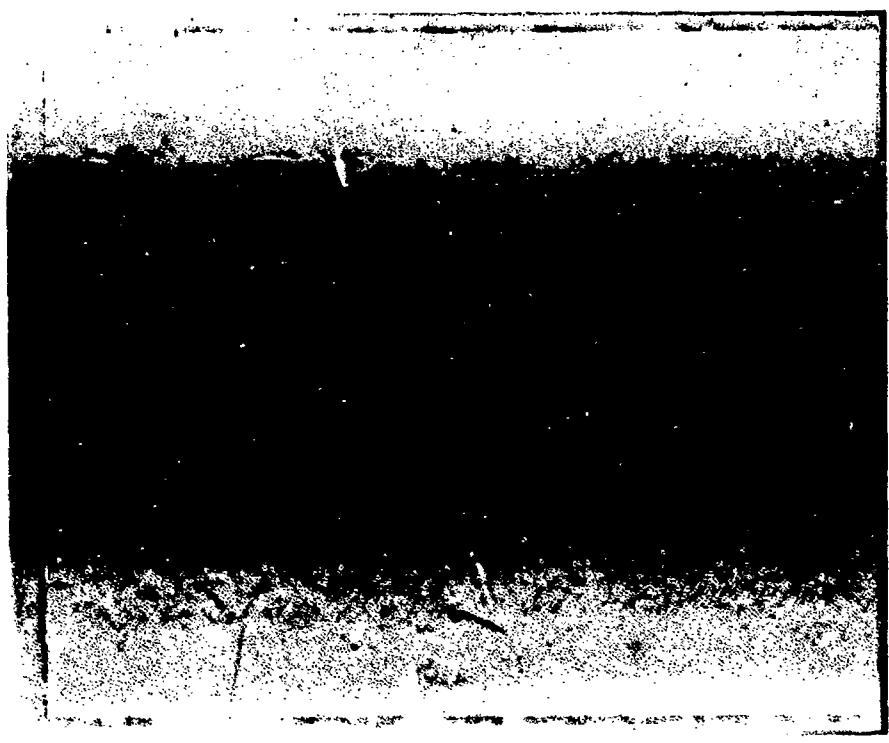
Figure 41 Final Fracture, Specimen 90G0704

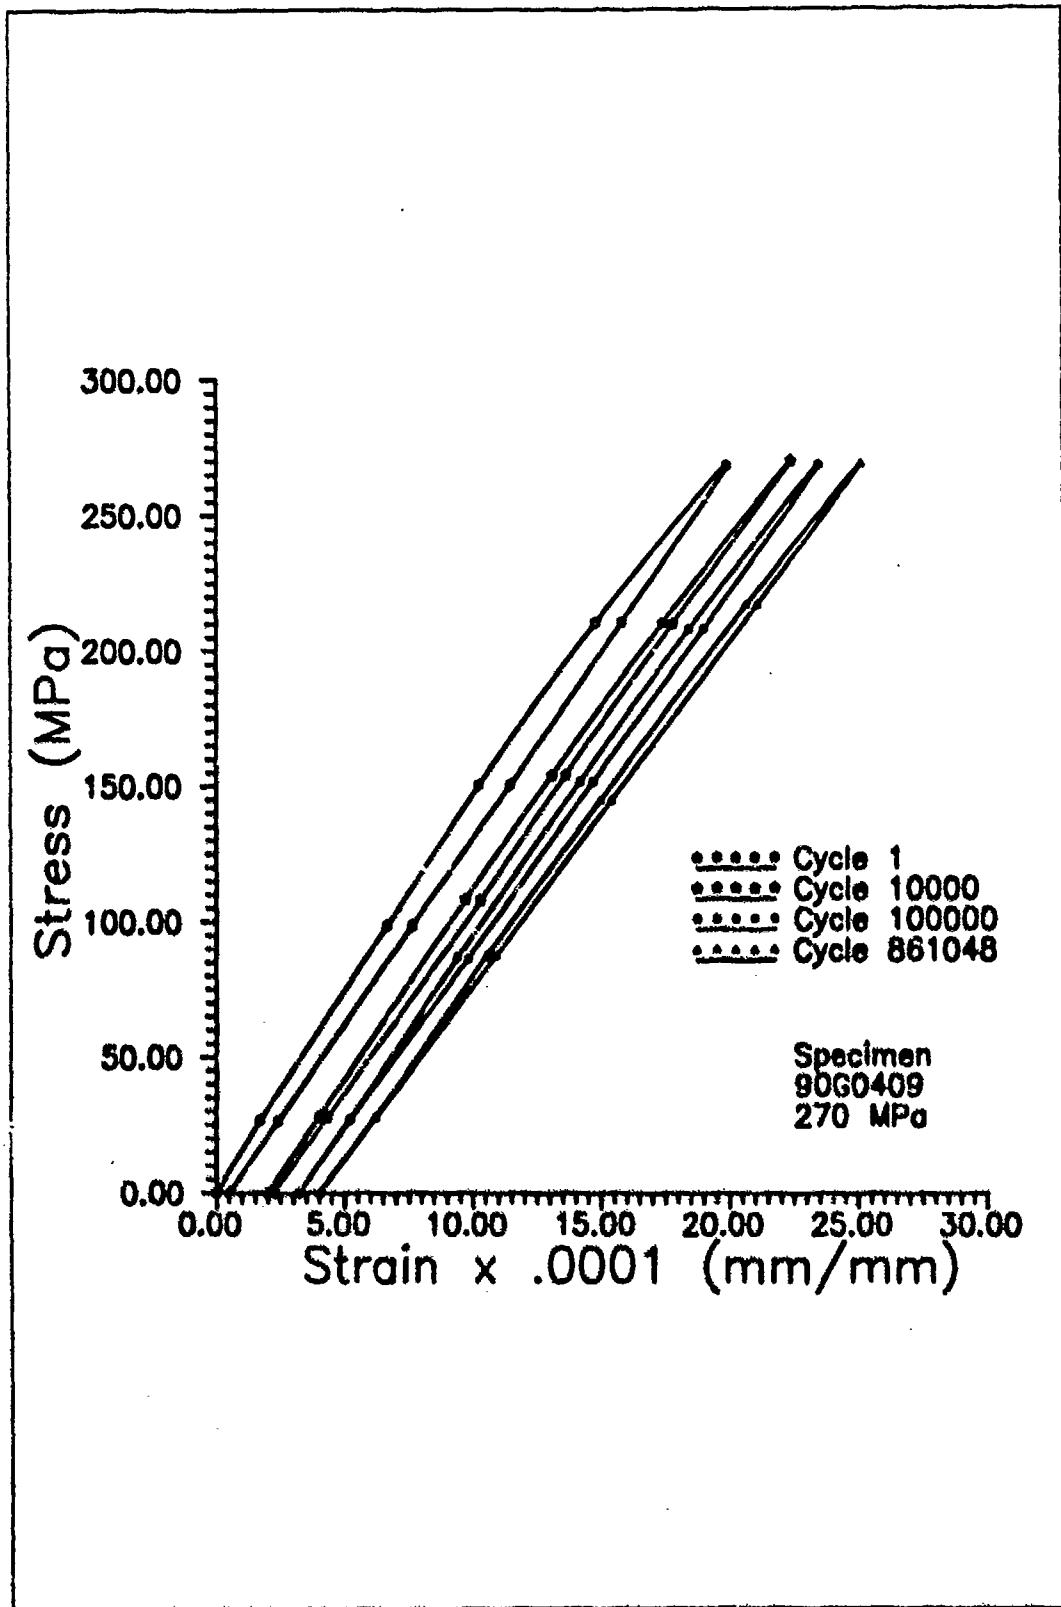
Figure 42 Stress vs. Strain 270 MPa Test

Specimen 90G0409 was tested at 270 MPa. As stated earlier, this was designed to be seventy-seven percent of ultimate. The results of the test are given in figure 42 and 43. Figure 42 depicts the stress-strain curves for the specimen. There is residual strain incurred albeit a small amount. The change in slope of the curves is minor. Once again, though, there appears to be a matrix microcrack closure level of approximately 80 MPa, where the slopes approach that of cycle one. The small change in slope is consistent with the results in figure 43. In this graph, a modulus degradation of only five percent occurred in the test.

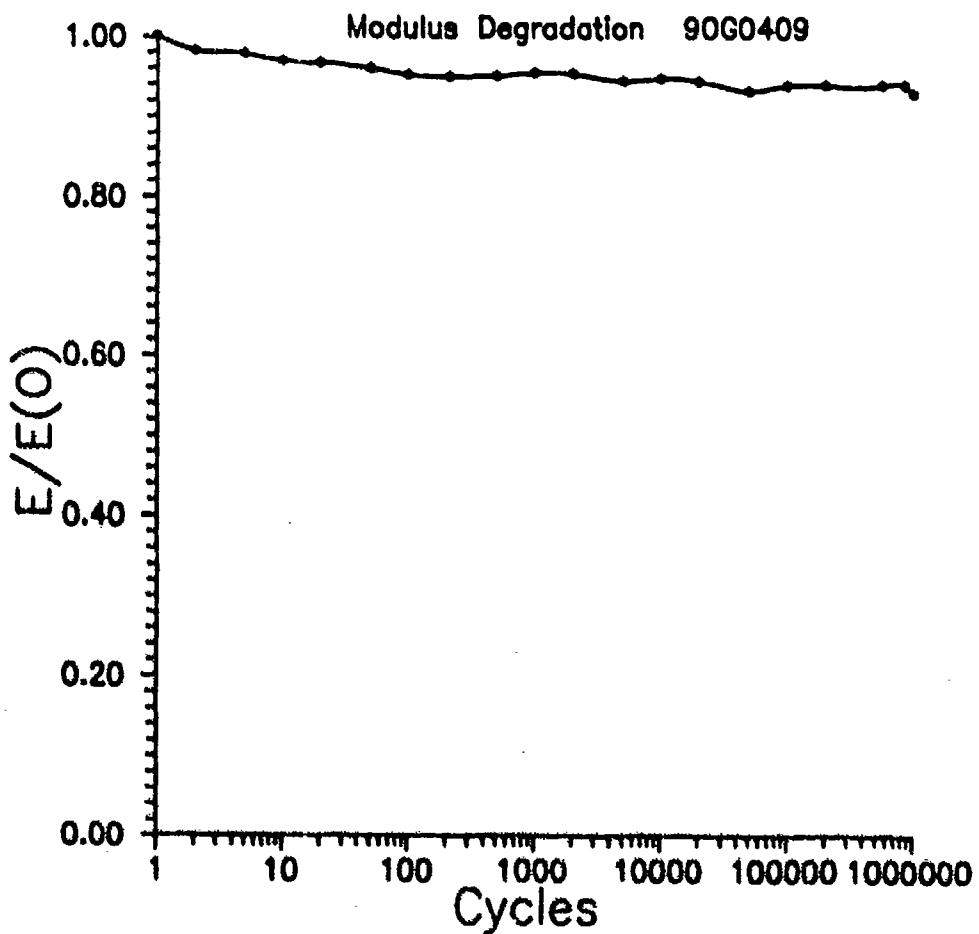
Figure 43 Modulus Reduction 270 MPa Test

Even though this change is less than those of the 90G03XX plate that ran-out with much less stress, the test was considered valid. Plate to plate property variations, due to processing, could account for these differences. This specimen did survive one million cycles of testing. Thus, an endurance limit could now be projected as occurring between eighty-three and seventy-seven percent of ultimate stress.

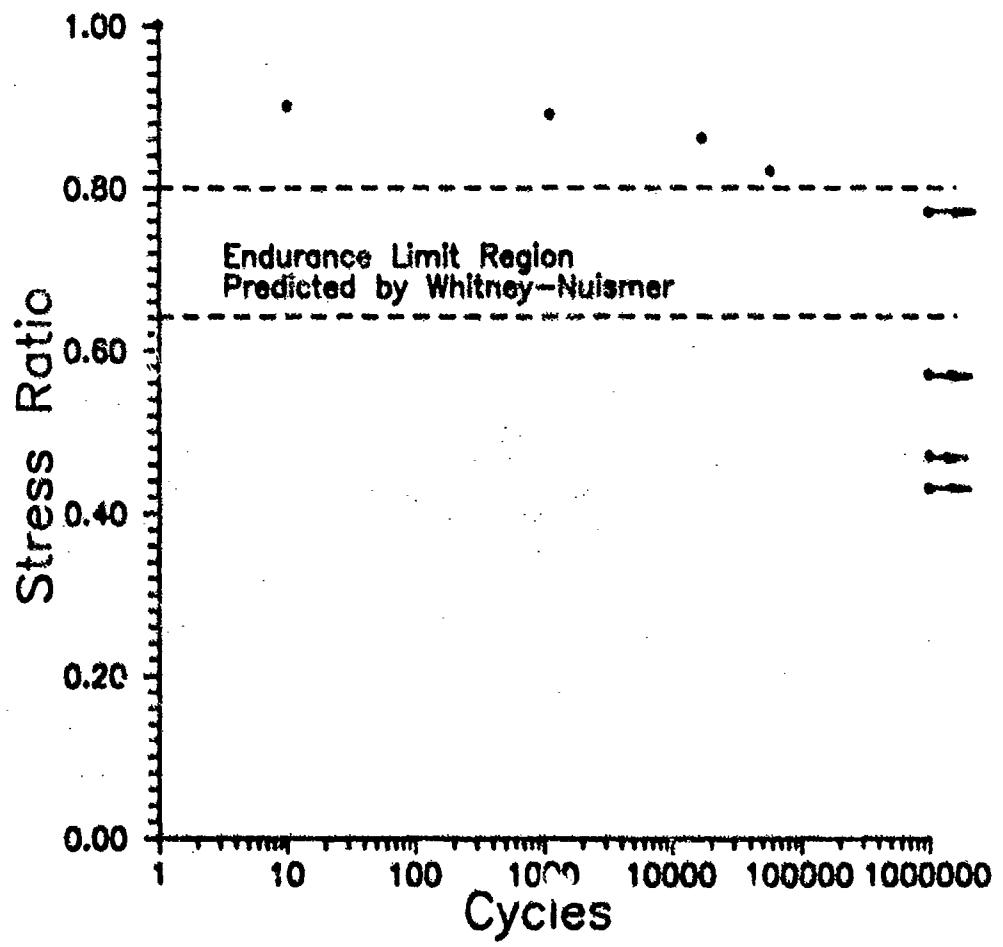
Figure 44 S-N Curve [0], Specimens

The final S-N curve is presented in figure 44. This figure clearly shows the dependence of fatigue life on applied maximum stress level. More importantly, there is a clear separation between failure and run-out, designated the endurance limit.

The calculated endurance limit from equations (40) and (41) yielded a range of 210 MPa to 259 MPa. These values were normalized by dividing them by the notched average ultimate stress of 324 MPa. The normalized ratios vary from .65 to .80. These endurance limit ratios are depicted in figure 44 as the dashed horizontal lines. The window that the model predicts is quite close to experimentally determined values. Therefore, Whitney-Nuismer is a good candidate for fatigue prediction of SiC/1723.

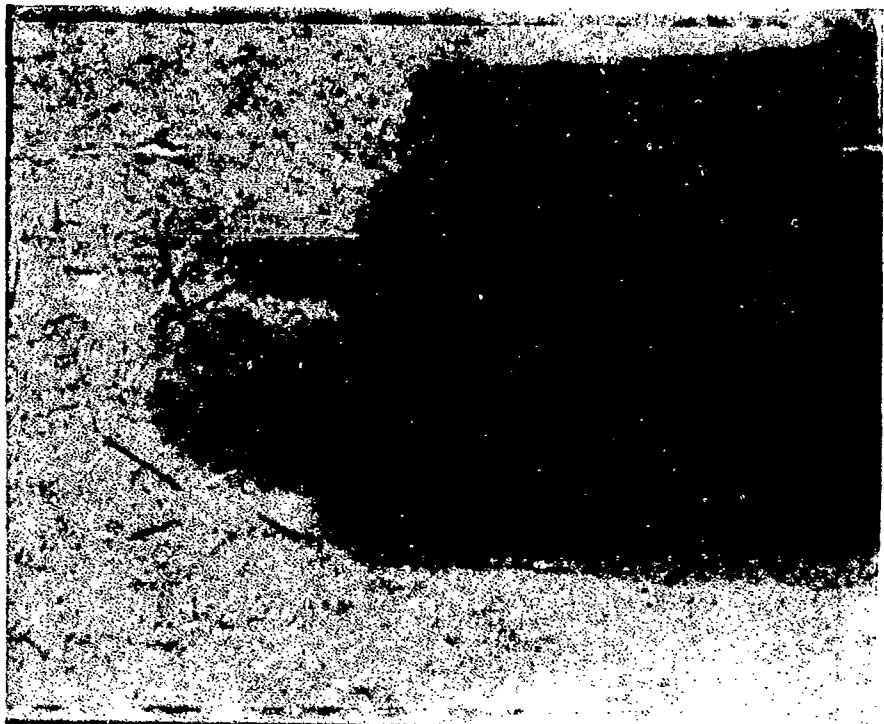
Figure 47 Final Fracture Specimen 91G0111

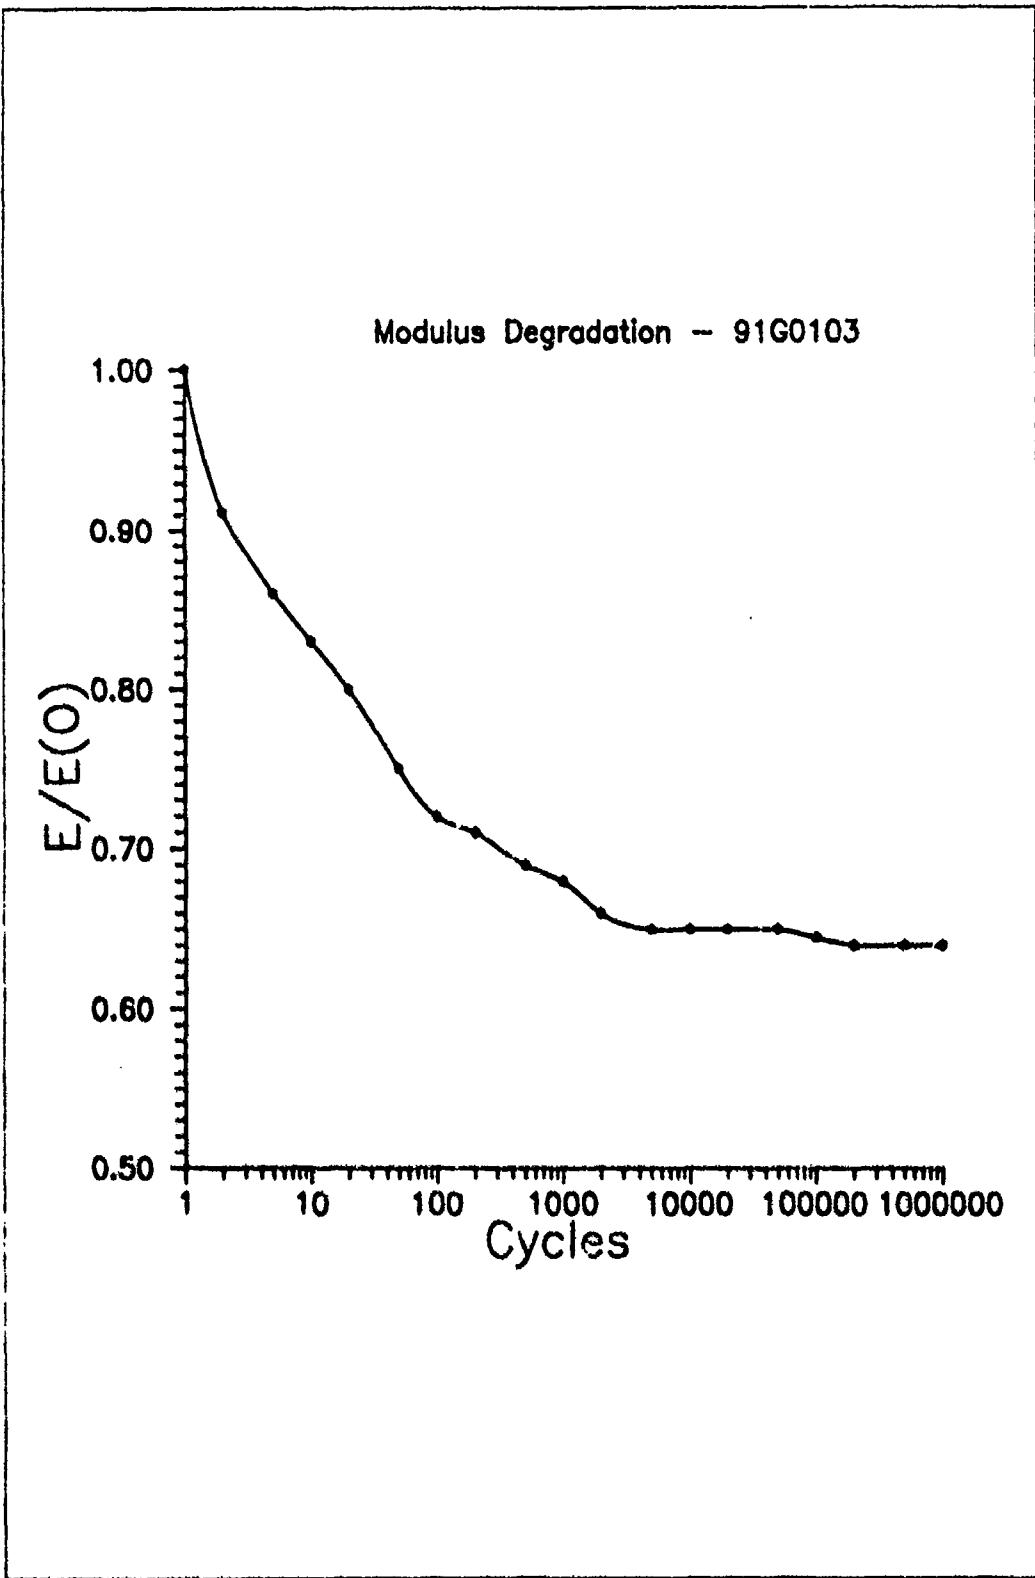
Figure 48 Modulus Reduction 88 MPa Test

Specimen 91G0103 was tested at a maximum stress of 88 MPa. Problems with the extensometer prevented accurate measurement of residual strain accumulation, however, modulus degradation was recorded. The results are shown in figure 48, modulus reduction over test life. This curve indicates damage occurs early in the test with a thirty percent reduction in stiffness by 1000 cycles. After 1000 cycles, the modulus stabilizes until run-out at one million cycles. Edge replicas were taken on this specimen to try and account for the steep early decrease in modulus. All replicas were taken under load based on results obtained by Marshall and Evans [36]. They found that cracks would close up as load was decreased, leading one to believe an area was damage-free when in fact, substantial cracking had transpired. A micrograph of a replica from the test is presented in figure 49. A matrix crack that has propagated through the middle two 90° plies is shown in the figure. The test produced cracking such as this randomly on the edge in the gage section. These cracks only appeared in the transverse plies. Notice that the crack appears to be deflecting longitudinally as it approached the 0° layer, which is shown at the bottom of the figure. The 90° plies appear as the region with circles, which are the cross-sections of the fibers running transverse to the loading direction. This damage corresponds with the sudden decrease in modulus shown in figure 48.

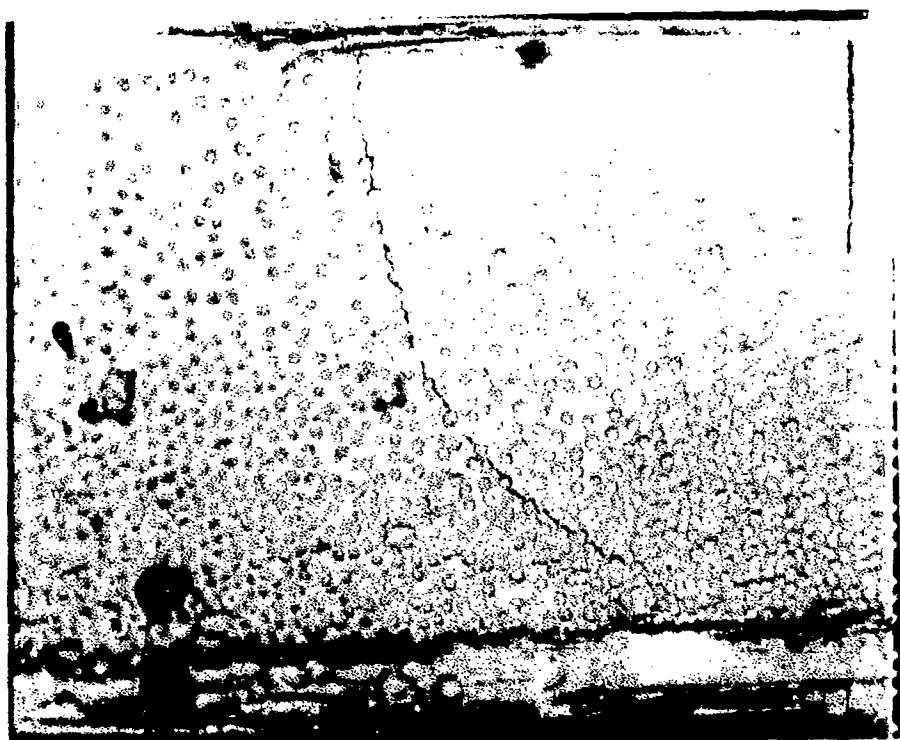
**Figure 49 Crack in Transverse Plies, 88 MPa Test
200X Magnification, Cycle 1026**

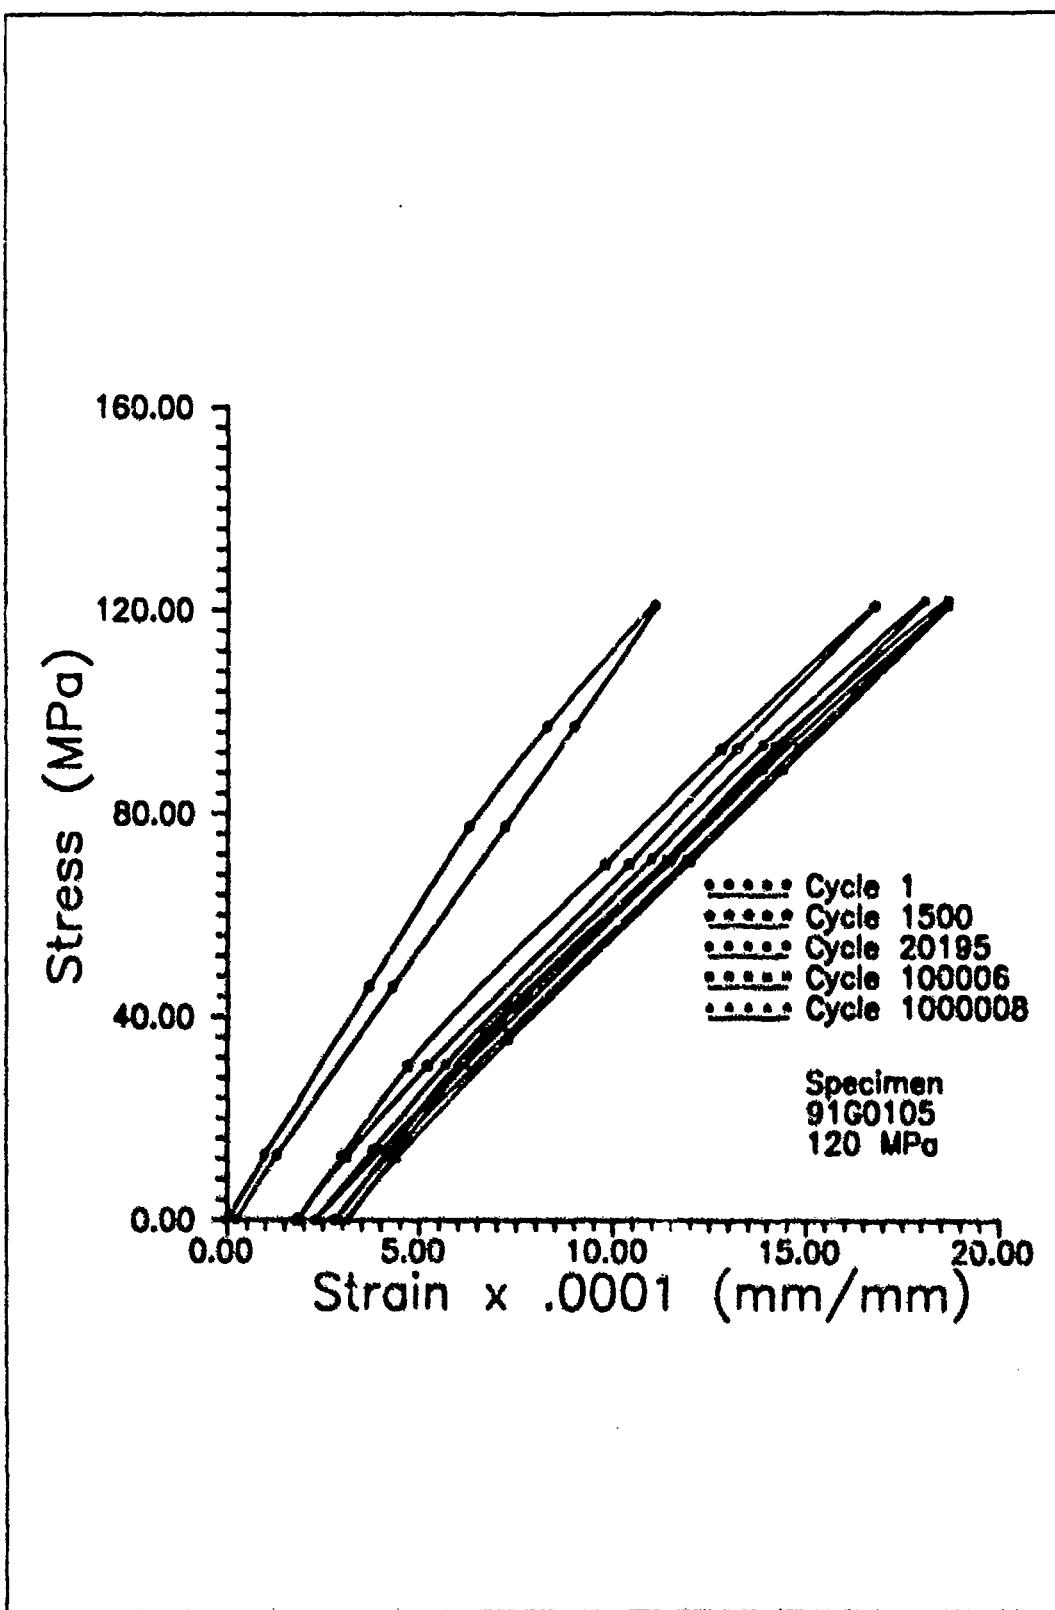
Figure 50 Stress Vs. Strain 120 MPa Test

The stress-strain curves show the non-linearity point of cycle one closely corresponds to the static tensile test specimens' first proportional limit. Subsequent tests show the matrix microcracking closure stress level seen in the unidirectional specimens. That stress level is constant regardless of cycle at approximately 40 MPa. Above 40 MPa, the cracks in the 90° plies are opened, allowing extension of the material and yielding a large change in slope or stiffness. Permanent damage that is not recovered by load elimination can be seen by the residual strain accumulation.

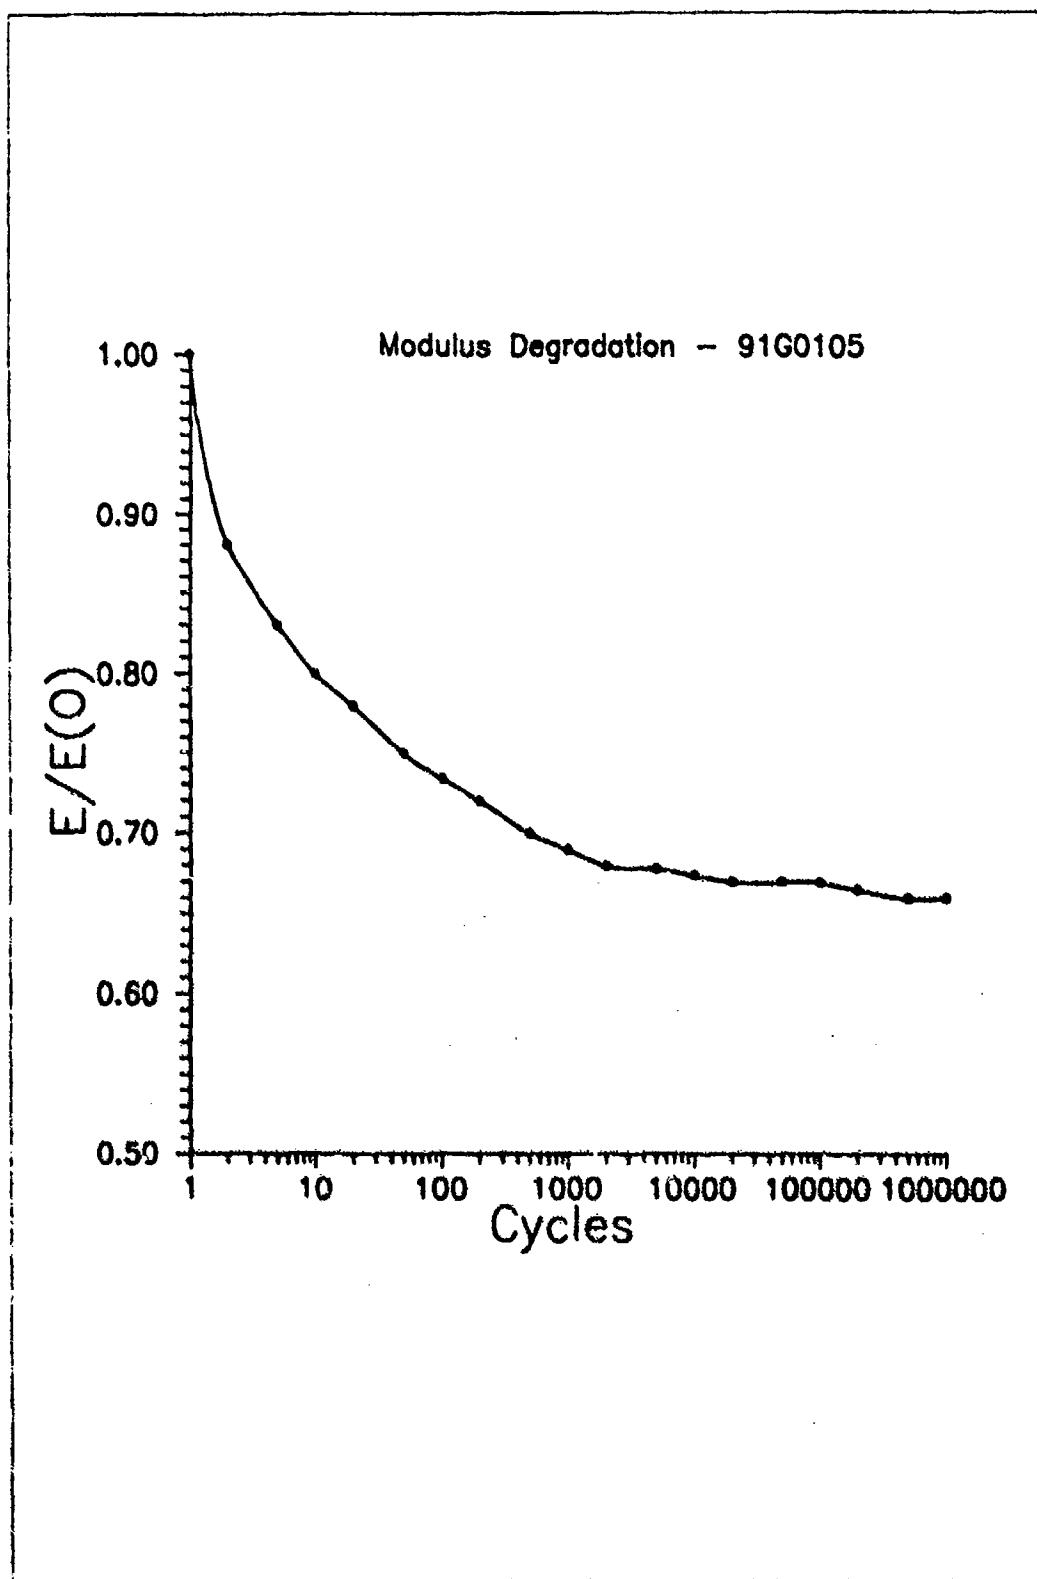
Figure 51 Modulus Reduction 120 MPa Test

Figure 51 shows the modulus degradation incurred by the specimen over the test life. As with the 88 MPa test, damage occurs swiftly in the 90° plies, stabilizing by one thousand cycles. This stabilization is shown further by examining stress-strain curves in figure 50. From cycle 1500 on, the slopes of the curves are nearly identical indicating little additional damage. An example of the damage in the specimen is shown in figure 52, which is a micrograph of an edge replica of the specimen. Damage was typical of this photograph. Transverse cracking spanned the 90° plies with delections at the 0°/90° interface. Longitudinal cracks can be seen in the 90° layers near the ply interface running parallel with the 0° laminae. Several cracks such as in figure 52 appeared in the gage length. However, the cracks were random in appearance and not evenly spaced, suggesting the specimen was not in a highly stressed state. This test also ran-out to one million cycles.

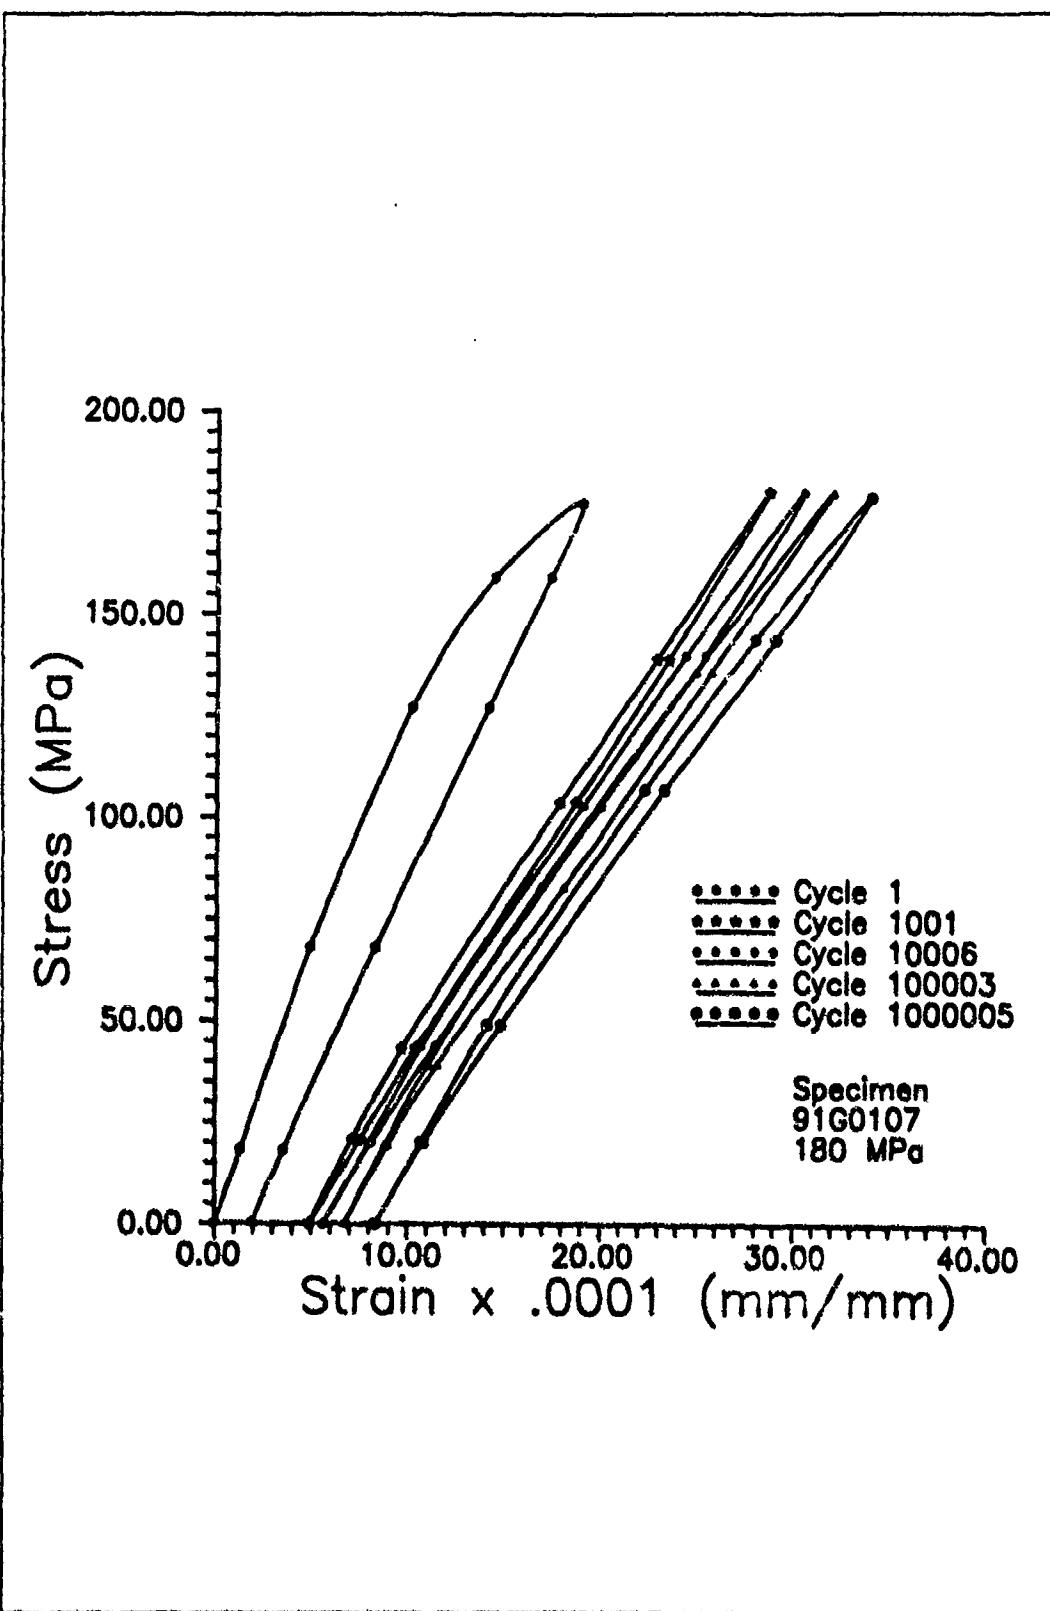
Figure 53 Stress Vs. Strain 180 MPa Test

Figure 53 shows the effects of the higher stress level on the laminate. The first cycle clearly depicts a much larger non-linear region than previous tests, suggesting higher levels of cracking than before. In addition, there is residual strain accumulation on the first cycle that was not present after the first cycle on the 120 MPa test. Total residual strain is almost double that of the 120 MPa test. The matrix microcrack closing stress seems to remain constant for it appears in figure 53 as 40 MPa, identical to the previous test. The slope of the stress-strain curves decrease greatly between cycle one and 1000, both above and below 40 MPa. After cycle 1000, the curves are nearly identical suggesting maximum damage has occurred early and has been retarded. This is supported by the results of figure 54, which show the modulus degradation. Extensive decreases in stiffness are shown, especially in the first ten cycles for this specimen. The stabilization of the modulus after 4000 cycles suggests no further damage is occurring.

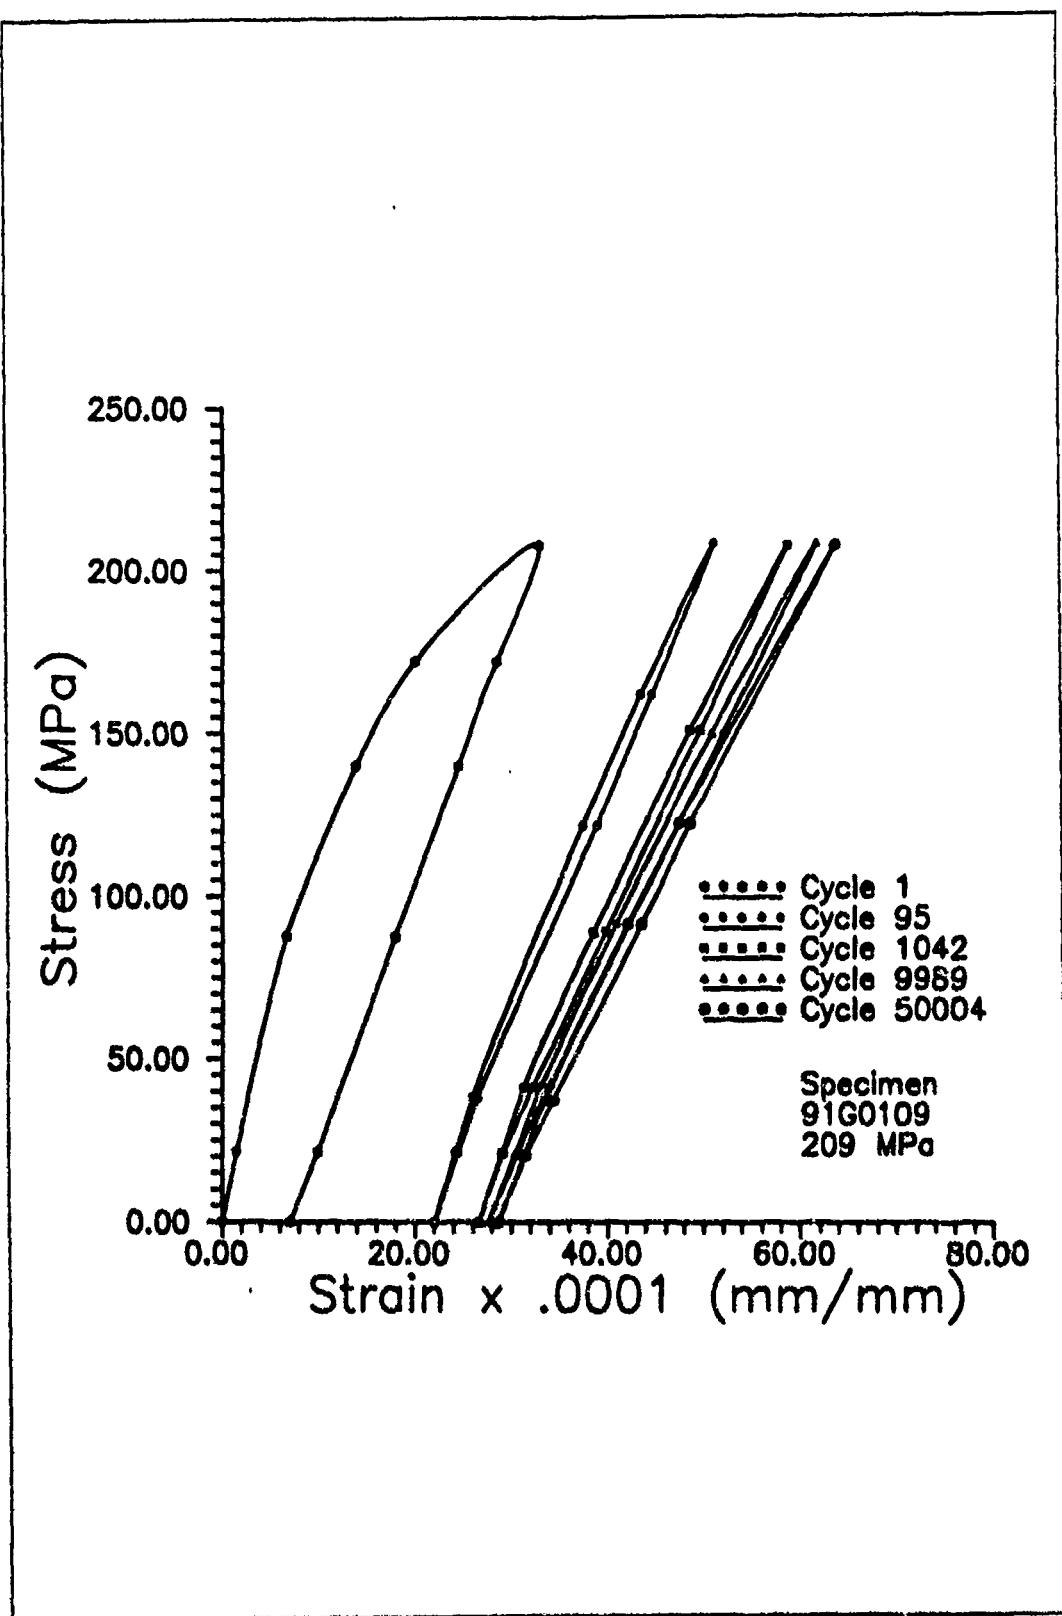
Figure 56 Stress Vs. Strain 209 MPa Test

The stress-strain curves of figure 56 show the effects of the high stress. Cycle one permanent strain accumulation is almost equal to the total residual strain of the 120 MPa test. This large residual strain component increased even more through 1042 cycles. Once again, the crack closure stress appears as 40 MPa. The decrease in slopes is substantiated by figure 57, which shows the modulus degradation. The stiffness is reduced early, typical of all bidirectional tests but instead of stabilizing, it continues to decrease until failure. Failure occurred at 87587 cycles.

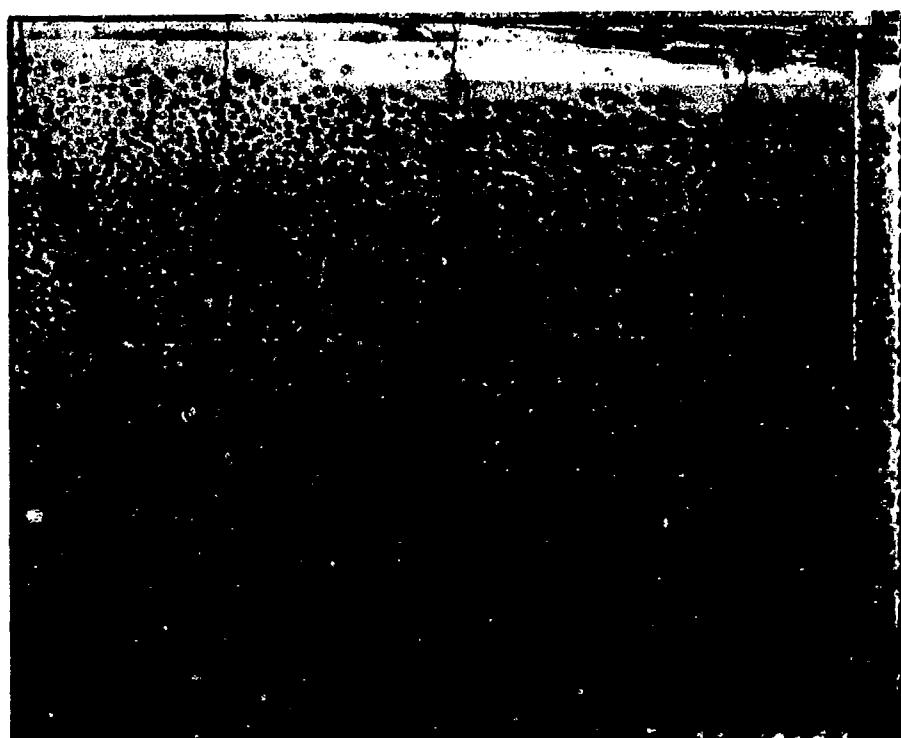
Figure 58 Regularly Spaced Transverse Ply Cracks
209 MPa Test, 200X Mag., Cycle 94

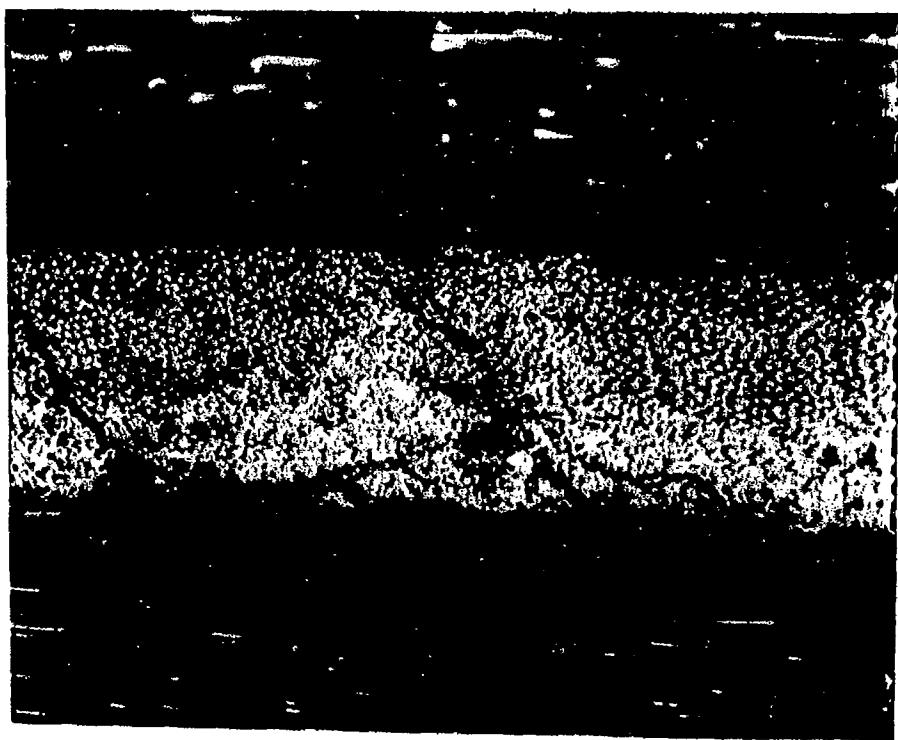
Figure 59 Transverse Ply Cracks Away From Hole
209 MPa Test, 100X Mag., At Failure

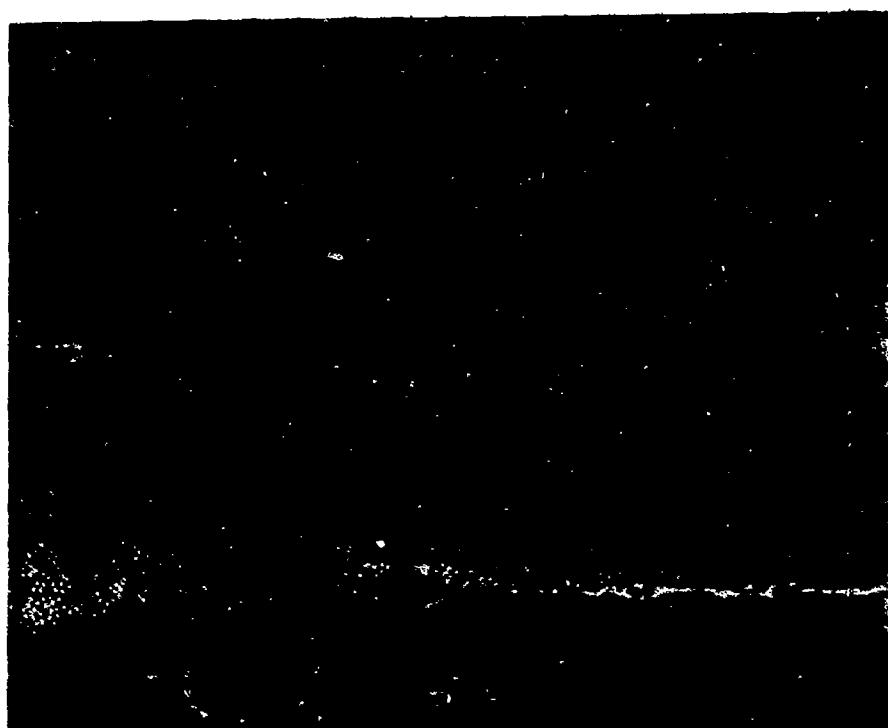
Figure 60 Transverse Ply Crack Far From Hole
209 MPa Test, 200X Mag., At Failure

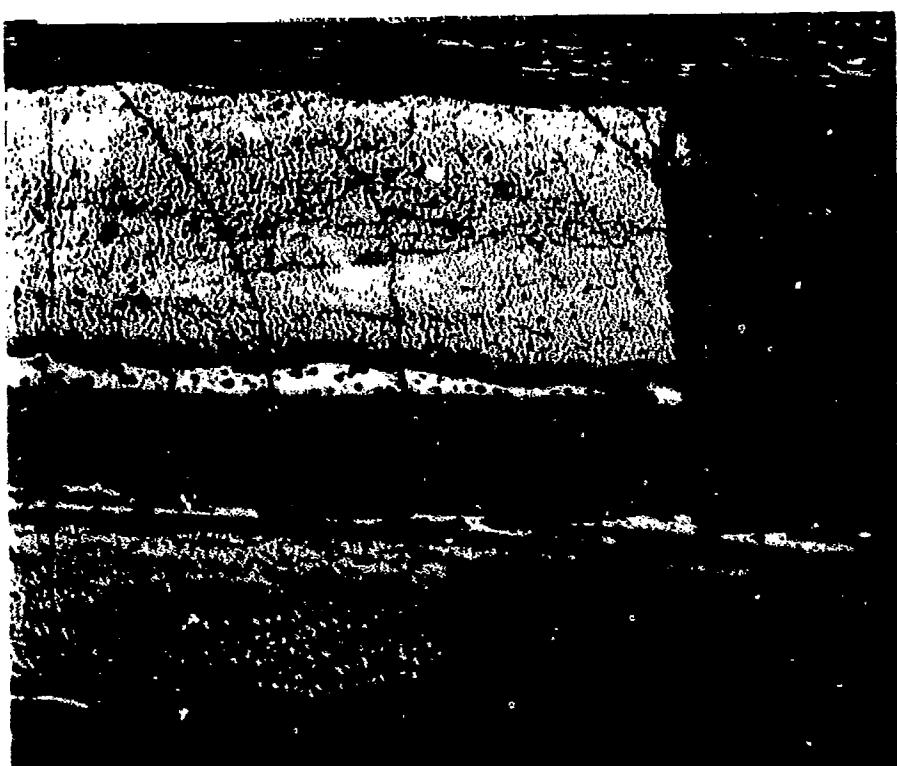
**Figure 61 Fracture Surface, Side View
209 MPa Test, 50X Magnification**
